# BELZONA 1212 SEALS A LEAK ON A WASTEWATER HOLDING TANK

**Industry:** Water / Wastewater  
**Application:** TCC-Tanks and Chemical Containment Areas  
**Substrate:** Concrete  
**Products:** \* Belzona 1212 ,

**Customer Location:** Washington, USA  
**Application Date:** March 2018

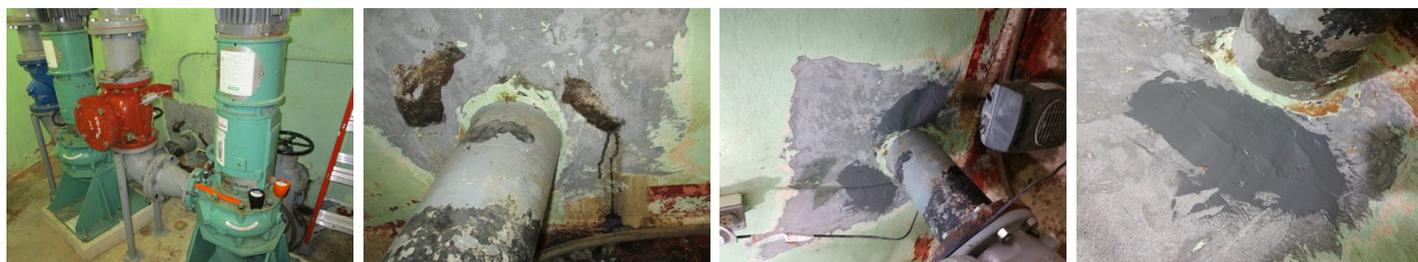
When the pipes were installed through the concrete wall, a grout was used to seal the area around the pipe. After many years of use, the grout began to fail, resulting in raw sewer water leaking into the pump room.

- \* Sub-level wastewater lift station pump room. ,
- \* Close up view of the leaking areas. ,
- \* Belzona 1212 application complete. ,
- \* Close up of one area of the application. ,

The application was carried out in accordance with TCC-5 Belzona System Leaflet. A grinder was used to remove the paint and the loose and damaged grout around the pipe. The leak was depressurized by lowering the contents of the concrete tank. The crack was explored until it became clear we were into solid concrete and had identified the exact location of the source of the leak. We discovered the raw sewer water was coming through on the bottom right area, but was splitting and coming through the wall there, as well as coming through the wall in the top left area. Both areas were packed full of Belzona 1212 and smoothed over so the Customer could repaint the wall later.
