BELZONA REPAIRS AND PROTECTS GAS STATION CONCRETE FLOOR

Application: *FPA-Floor Problem Areas*

Application Date: *July 2018*

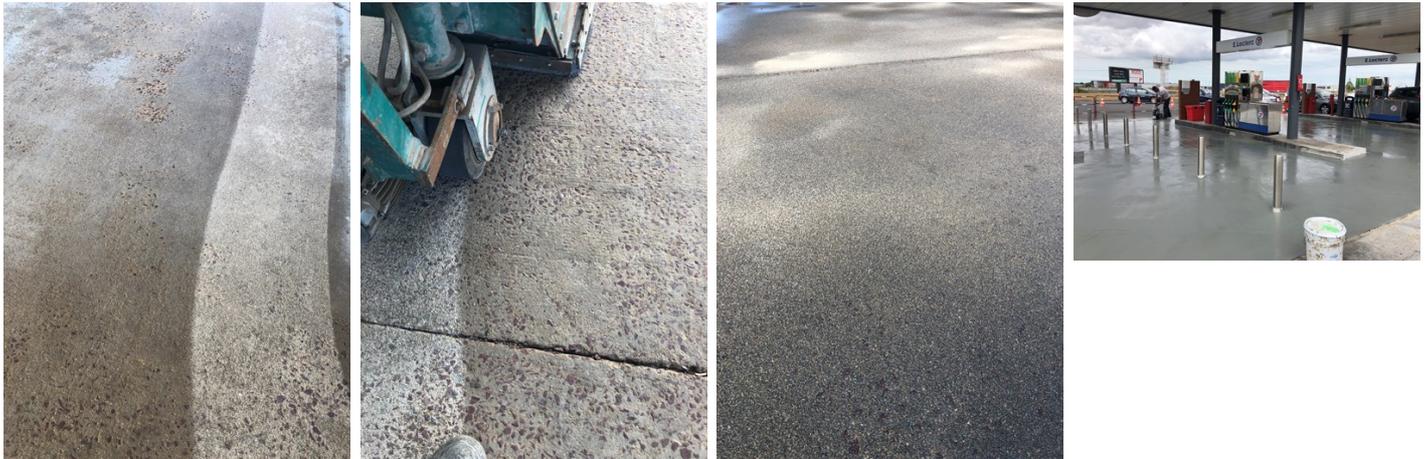
Photograph Descriptions

The concrete floor of this gas station was attacked by gas and needed to be resurfaced and protected. Because it can easily get slippery it also needed a slip-resistant system.

* 1- Damaged and slippery concrete 2- Grit blasted concrete 3- Resurfaced concrete with silica 4- Final result with Belzona 5811 ,

The concrete floor of this gas station was damaged, greasy and slippery.

The floor was steam cleaned the grit blasted. The concrete has then been resurfaced with Belzona 4151 and covered with Silica 0.5-1.25 using Belzona Know-How system leaflet FPA-8. 4 hours later, Belzona 5811 was applied on top of the silica to complete the non-slip system and protect the surface from hydrocarbons.
