# BELZONA SUPER METAL RESTORES STRUTS ON A DREDGING VESSEL

ID: 7762

Struts supporting propulsion system and housing cutlass bearings on 200 foot dredging vessel.

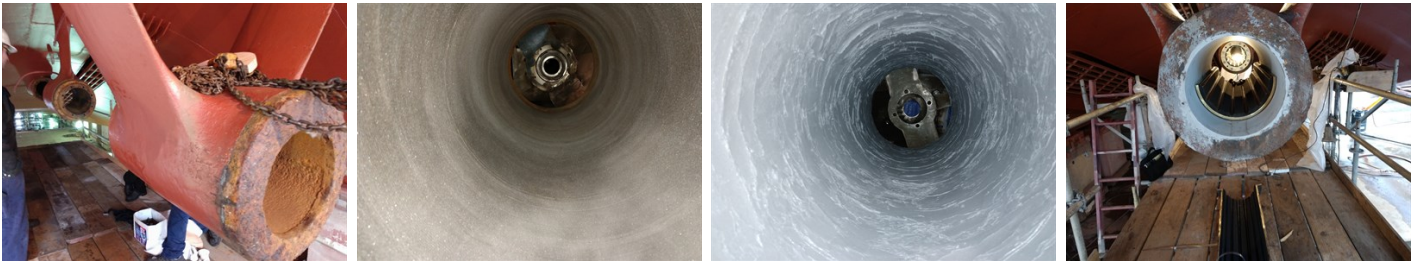
*The internals of all 4 struts had suffered erosion and corrosion from seawater and needed to be restored.*

- \* 2 of 4 struts that needed restoration ,
- \* A clean, solid, roughened substrate ,
- \* Surface built up with Belzona 1111 ,
- \* Completed application ready for cutlass bearings ,

The application was carried out in accordance with SOS-9 BelzonaKnow-How System Leaflet. The substrate was machined down via boring to achieve a clean, solid substrate free of any corrosion. Substrate was then blasted with an angular grit to give a minimum surface profile of 3 mils. Substrate was then power washed with HoldTight 102 to bring salt contamination to acceptable levels. Belzona 1111 was then mixed and applied to build up the surface proud and then once cured, machined back to tolerance.
