# Expansion joint rebuild done right with Belzona

ID: 7763

Hospital construction joint.

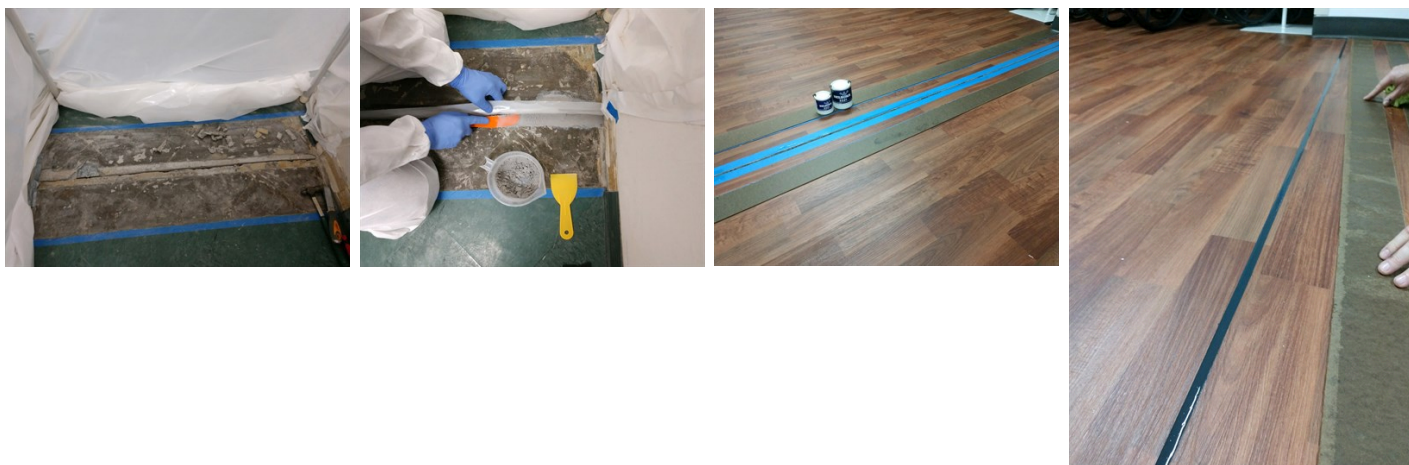
This was a construction joint from when the hospital was expanded. No expansion joint was installed, it was just concrete against concrete. Over the years the expansion and contraction caused the concrete at the seam to break and crumble. The metal and rubber expansion joint strip mounted over it also caused a bump in the floor.

- \* 1. VCT tiles removed and damaged concrete being removed. Notice the large area broken out on the left side. ,
- \* 2. Applying the Belzona 4111 on either side of the former. ,
- \* 3. Ready to pour the Belzona 2221, waiting for the Belzona 2911 to cure. ,
- \* 4. Tape removed. Completed successful application. ,

The original VCT flooring tiles were removed from either side of the seam. The loose and broken concrete was removed. The remaining concrete was ground back to open up space between the two sides. Belzona 4911 and 4111 were applied with the use of a plastic wrapped former to leave a nice squared, even area for the expansion joint to be created. The new full sheet vinyl flooring

was then installed over the new joint and allowed to cure. A week later we came back and cut the vinyl flooring to expose the space between the concrete sections. The Belzona 2911 was applied and allowed to cure according to the Instructions For Use. Foam backing rod was inserted to a depth that was equal to half the width of the joint. Both sides were carefully taped off and the Belzona 2221 was then mixed and poured into the joint. Using a Belzona applicator, the excess Belzona 2221 was scraped off leaving it level with both sides of the new vinyl flooring. The tape was then removed and a bridge was placed over the joint to allow for hospital beds, carts, and staff to pass over it during the cure time. After 24 hours, the bridge was removed leaving a nice smooth, clean transition.
