Belzona repairs leaky pipes from a heat exchanger

ID: 7765

Industry: Customer Location: *France*
Application: *HEX-Heat Exchangers* Application Date: *August 2018*
Substrate: *Carbon steel*
Products: ** Belzona 9111 (Cleaner Degreaser) Belzona 1111 (Super Metal) Belzona 5892 ,*

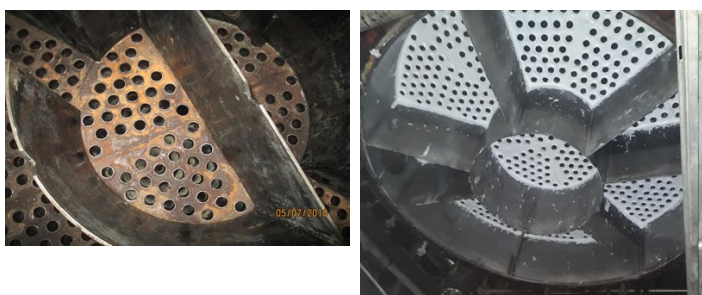
Photograph Descriptions

Sealing problem between the tubes and the tubular sheet on these heat exchangers due to a bad tube expansion, 50% of the tubes were leaking.

* 1- View of the equipment before application 2- Final application ,

The tubular sheet and the tube ends were grit blasted and cleaned with Belzona 9111 (Cleaner Degreaser) . Belzona 1111 (Super Metal) was used to rebuild the profile between the tubes and substrate then Belzona 5892 was applied on top for further protection against aqueous solutions. The application was carried out in accordance with a modified version of HEX-1 followed by HEX-3 Belzona System Leaflet
