Belzona Repairs and Protects the Roof of Storage Silos

Application: RPA-Roof Problem Areas

Asphalt coated roofs of four storage silos.

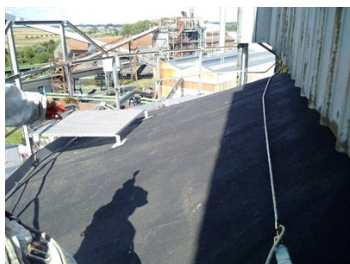
The water infiltration through the asphalt sheets on storage silos was causing a lot of corrosion and holes on the metallic roof underneath. This caused the degradation of the stored products (pellets for animal feed).

- * Previous asphalt coating used for roof protection. ,
- * Belzona 3111 used on the previous coating welds. ,
- * Final application. ,
- * Overview of the silos. ,
