Belzona Repairs and Protects the Roof of Storage Silos

Application: *RPA-Roof Problem Areas*

Asphalt coated roofs of four storage silos.

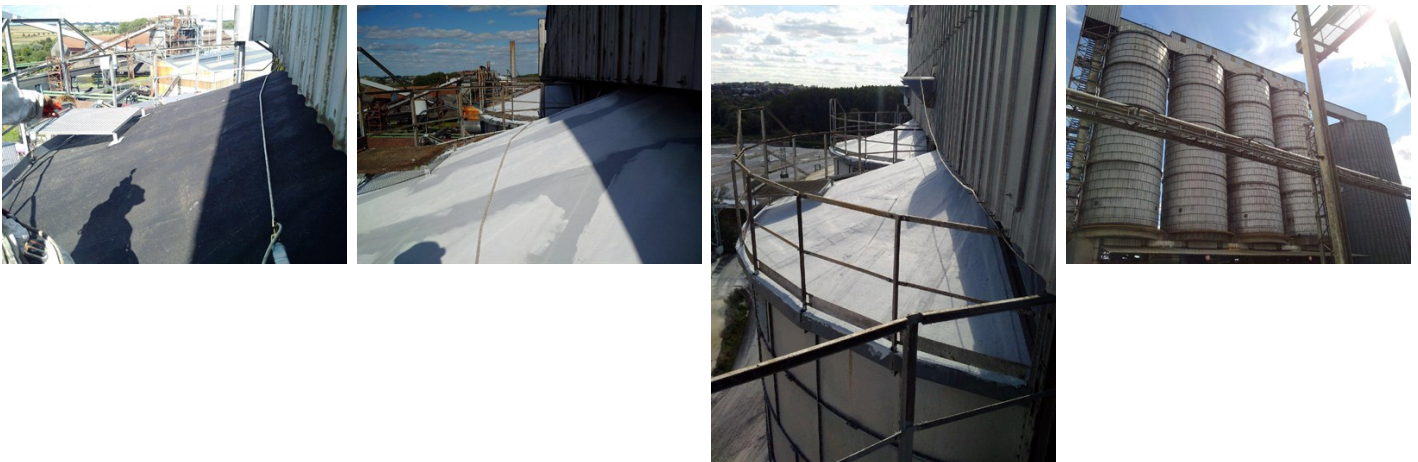
Photograph Descriptions

The water infiltration through the asphalt sheets on storage silos was causing a lot of corrosion and holes on the metallic roof underneath. This caused the degradation of the stored products (pellets for animal feed).

- * Previous asphalt coating used for roof protection. ,
- * Belzona 3111 used on the previous coating welds. ,
- * Final application. ,
- * Overview of the silos. ,

The surface was pressure washed and thoroughly inspected to detect the particularly affected areas. Belzona 3911 was first applied on the whole surface. Then, two coats of Belzona 3111 were used with a reinforcement sheet (Belzona 9311) in accordance with a modified version of Belzona Know-How System Leaflet RPA-10.
