Belzona protects the inside of hot liquor tanks in a brewery

ID: 7771

Industry: Food & Drink
Application: TCC-Tanks and Chemical Containment Areas
Substrate: Mild steel
Products: * Belzona 5892 ,

Customer Location: Tadcaster, UK
Application Date: 2018

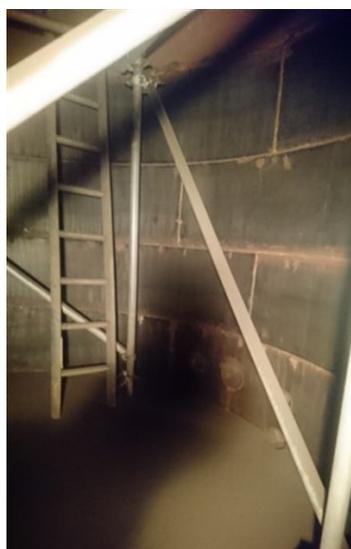
* 1- Blasted tank before application 2- Pit holes on the inside of the tank 3- Conditions inside the tank 4- Final application ,

The previous liner was removed by grit blasting, this step took 3 days. Once the pit holes under the liner had been repaired, two coats of Belzona 5892 were applied to the first two hot liquor tanks using Belzona Know How System Leaflet TCC-5. Belzona 5892 was cured with hot water and washed down twice.

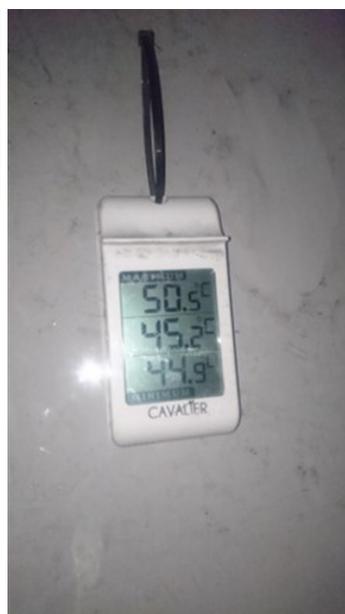
This brewery has 6 liquor tanks which operate at 85°C, they were all coated with an unknown liner which was failing. The location of the tanks meant that the client could not replace them and a high performance coating was required. The protective coating also had to have a potable water approval.
