Belzona protects the inside of hot liquor tanks in a brewery

ID: 7771

Customer Location: Tadcaster, UK
Application Date: 2018

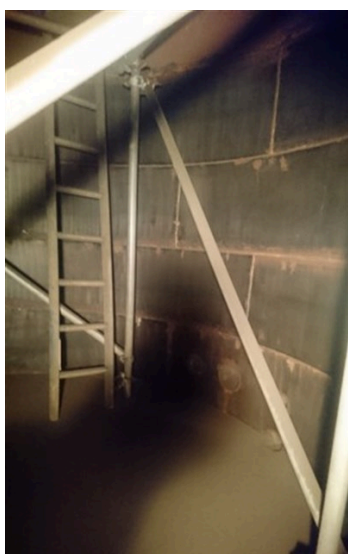
* 1- Blasted tank before application 2- Pit holes on the inside of the tank 3- Conditions inside the tank 4- Final application ,

The previous liner was removed by grit blasting, this step took 3 days. Once the pit holes under the liner had been repaired, two coats of Belzona 5892 were applied to the first two hot liquor tanks using Belzona Know How System Leaflet TCC-5. Belzona 5892 was cured with hot water and washed down twice.

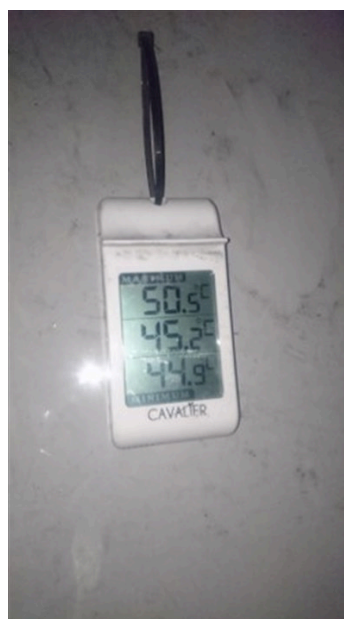
This brewery has 6 liquor tanks which operate at 85°C, they were all coated with an unknown liner which was failing. The location of the tanks meant that the client could not replace them and a high performance coating was required. The protective coating also had to have a potable water approval.
