# Belzona Repairs Tank Leg Supports at a Distillery

Industry: *Food & Drink*  
 Application: *TCC-Tanks and Chemical Containment Areas*  
 Substrate: *Steel*  
 Products: *\* Belzona 5811 (Immersion Grade),*

Customer Location: *United Kingdom*  
 Application Date: *2018*

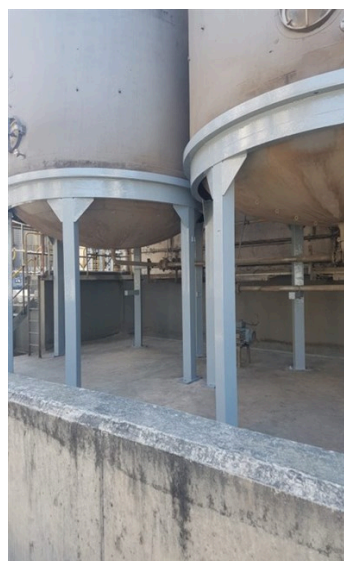
*Several VAT tank leg supports were corroded due to the break down of the original paint system. Some tanks had already been condemned due to metal loss and through wall defects in the tank supports.*

- \* Damaged tank leg supports ,
- \* Damaged tank leg supports ,
- \* 1st coat of Belzona 5811 ,
- \* Application after 1 year in service ,

The previous paint was removed by saturation blasting to keep the dust levels down on-site. The VAT legs were then coated by hand with Belzona 5811 in accordance with a modified version of Belzona Know-How System Leaflet TCC-5.

The application was re-visited 1 year later, and found to still be forming with no damage or repairs required.
