# Belzona Elastomers Rebuild Flange Gasket on a Cruise Ship

ID: 7778

Cruise ship flange gasket rebuilding.

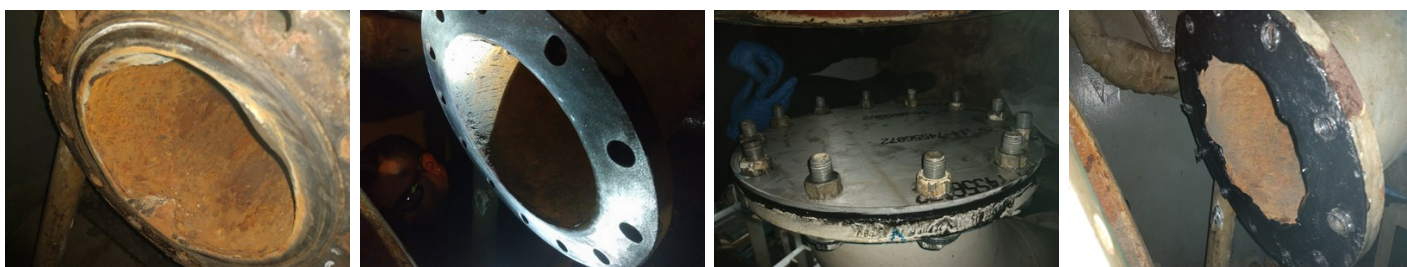
Flowing seawater had degraded the original gaskets on several flanges of this 963 foot cruise ship. Further damage was caused by the removal of adjacent valves for service.

- \* Damaged gasket on flange. ,
- \* Surface prepared and ready for Belzona Elastomer rebuild. ,
- \* Former applied, Belzona 2121 curing. ,
- \* Former removed to reveal rebuilt gasket. ,

Application was completed with a modified version of Belzona System Leaflet GSS-1 for creating gaskets. Damaged gasket material was removed. Steel substrate was cleaned and abraded with a grinder and MBX Bristle Blaster. The surface of the flange was then treated with a thin coat of Belzona 2911. Once the conditioner cured the flange face gasket was built up with Belzona 2121. A custom former or Blank that had been coated with a release agent was then lightly bolted onto the flange face to reform the gasket. Once Belzona 2121 had cured the former was removed to reveal the new gasket. Any excess material was then cut away with a razor blade.
