Belzona Internal Protective Lining of a Hot Water Tank

ID: 7782

Customer Location: Office Building, KS, USA
Application Date: October 2018

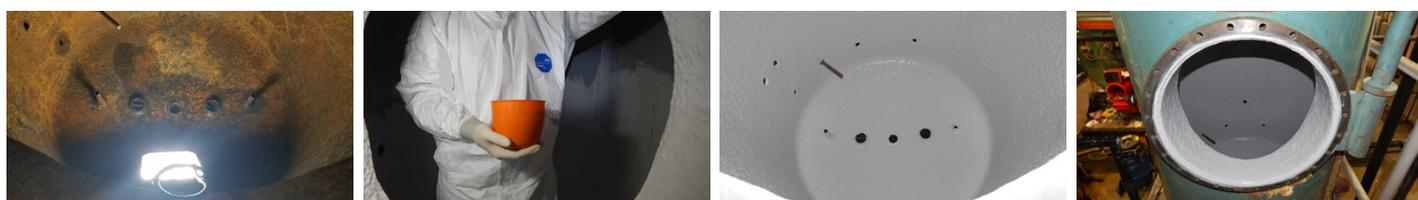
A hot water tank in the basement of the State Building had sprung a small leak. The owners worried that this was only the first to come for the old tank and Belzona was called to repair the leaking area and to line the tank with a coating to prevent further decay of the metal thus preventing more leaks from occurring.

* Tank conditions before the repair.
/>First coat being applied.
/>Finished Application.
/>Finished Application. ,

First the tank was sandblasted, vacuumed out, washed with acetone, and then any holes, thin spots, or areas with extreme metal loss were rebuilt with Belzona 1511. After the rebuild metal had hardened the interior of the tank was coated with Belzona 5892, and the next day a second coat of Belzona 5892 was applied to finish the application.
