Residential Roof Repaired by Belzona

ID: 7784

Application: RPA-Roof Problem Areas

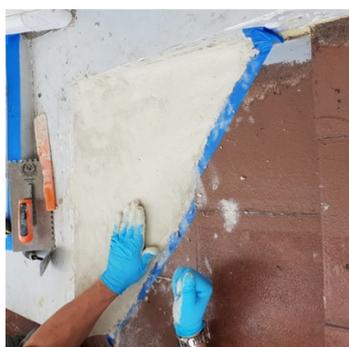
Rain water was pooling and penetrating under the roofing tiles. Several attempts were made with silicon and mastic materials to address the problem.

* Picture 1 - The roofing area Picture 2 - Rebuilding with Belzona 4141 Picture 3 - Application of Belzona 3111 Picture 4 - The completed application ,

A residential building had an extension retrofitted, however water was penetrating between the house and the new roofing area.

Belzona 4141 was used to recontour the area subjected to pooling of water. Belzona 3111 was then applied between the wall of the house and the extension roofing tiles.
