# Residential Roof Repaired by Belzona

ID: 7784

Industry:	Buildings & Structures	Customer Location:	Thailand
Application:	RPA-Roof Problem Areas	Application Date:	October 2018
Substrate:	Roofing Tiles		
Products:	* Belzona 4141 Magma Build Belzona 3111 Flexible Membrane ,

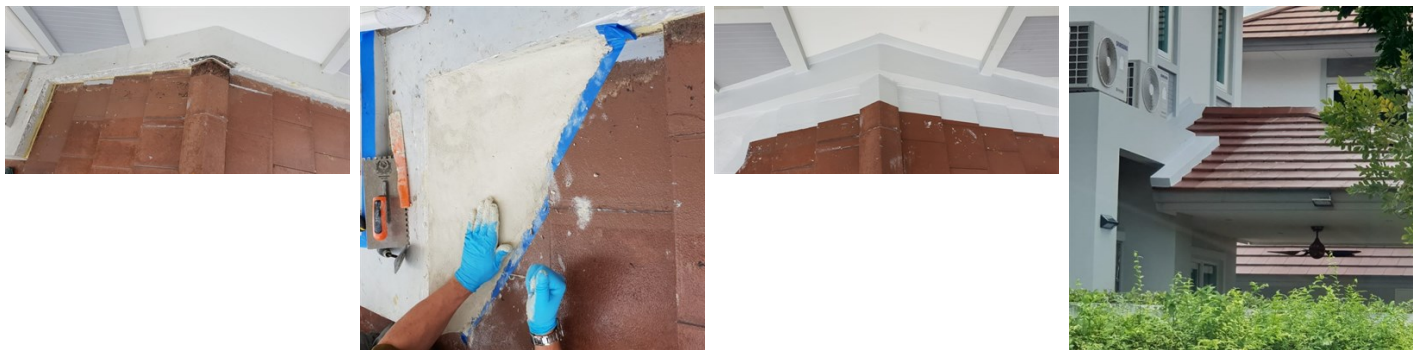
Rain water was pooling and penetrating under the roofing tiles. Several attempts were made with silicon and mastic materials to address the problem.

\* Picture 1 - The roofing area Picture 2 - Rebuilding with Belzona 4141 Picture 3 - Application of Belzona 3111 Picture 4 - The completed application ,

A residential building had an extension retrofitted, however water was penetrating between the house and the new roofing area.

Belzona 4141 was used to recontour the area subjected to pooling of water. Belzona 3111 was then applied between the wall of the house and the extension roofing tiles.
