Residential Roof Repaired by Belzona

Application: RPA-Roof Problem Areas

Application Date: October 2018

Substrate: Roofing Tiles

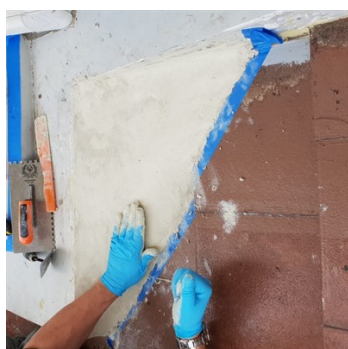
Rain water was pooling and penetrating under the roofing tiles. Several attempts were made with silicon and mastic materials to address the problem.

* Picture 1 - The roofing area Picture 2 - Rebuilding with Belzona 4141 Picture 3 - Application of Belzona 3111 Picture 4 - The completed application ,

A residential building had an extension retrofitted, however water was penetrating between the house and the new roofing area.

Belzona 4141 was used to recontour the area subjected to pooling of water. Belzona 3111 was then applied between the wall of the house and the extension roofing tiles.
