# BELZONA PREVENTS WATER PENETRATION INTO A DATA STORAGE FACILITY

ID: 7786

Industry: *Commercial Facilities*  
Application: *FPA-Floor Problem Areas*  
Substrate: *Concrete*  
Products: *\* Belzona 4111(Magma-Quartz) ,*

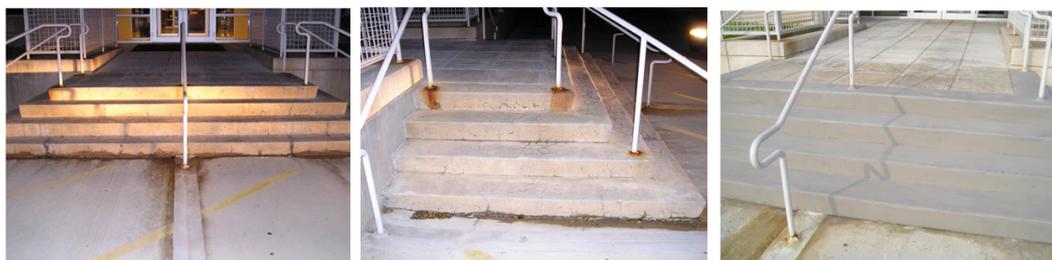
## Photograph Descriptions

*Spider cracks compromising the integrity of the staircase and allowing water to penetrate into the building's data center underground.*

\* Showing Damage After powerwashing Completed application; the cracks filled, and the steps re-surfaced with Belzona 4111 for a long-term protection ,

The entire repair was complete on a Saturday afternoon after employees vacated the building. The cracks were filled with Belzona 4111 and the entire surface was restored for waterproofing and a long-lasting protection.
