DATA CENTER'S ENGINEERING ROOM WATERPROOFED WITH BELZONA

ID: 7788

Customer Location: Virginia, USA
Application Date: October 2011

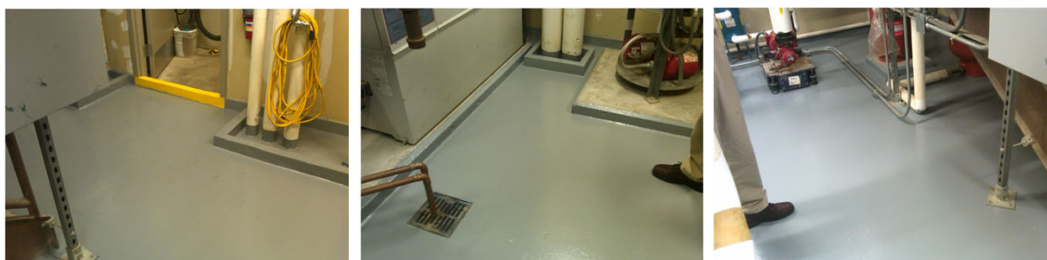
Photograph Descriptions

This engineering room caused water penetration into a critical facility located below. The leaks were caused by the drain being located at a higher elevation than the floor, the lack of sealant around the drains, lack of curbs and thresholds to keep the water contained, lack of concrete sealant.

* Threshold built with Belzona 4131 and made "safety" visible with Belzona 4411 Curbs around the piping built with Belzona 4131. The floor is coated with Belzona 5231 Application is completed ,

Belzona materials were used to install new curbs and thresholds and to provide a protective sealant to the flooring. Belzona 3121 was used to seal the areas between piping and the floor. The threshold at the door and curbs around the piping were built with Belzona 4131. To avoid a trip hazard and to ensure safety the thresholds were coated with Belzona 4411 Yellow. Then, the entire floor was coated with Belzona 5231 for chemical and water protection as well as to provide a non-slip and easy-to-clean finish. No more leaks jeopardizing the critical facility below.
