HOSPITAL'S ENGINEERING ROOM EXPANSION JOINTS WATERPROOFED WITH BELZONA

ID: 7789

Industry: *Commercial Facilities*
Application: *FPA-Floor Problem Areas*
Substrate: *Concrete*
Products: ** Belzona 2221 (MP Fluid Elastomer) Belzona 4111 (Magma-Quartz) ,*

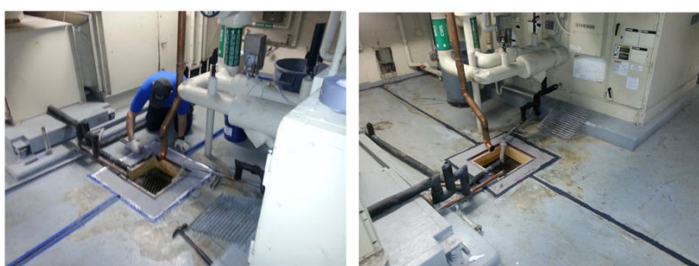
Photograph Descriptions

* Concrete restoration with Belzoa 4111 New joint installation with Belzona 2221 ,

First, the existing joint material was removed, and the concrete was restored with Belzona 4111. A new joint was installed using a foam backer rod and Belzona 2221.
