# Propeller Shaft Protected with Belzona Coatings

ID: 7791

Marine vessel propeller shaft.

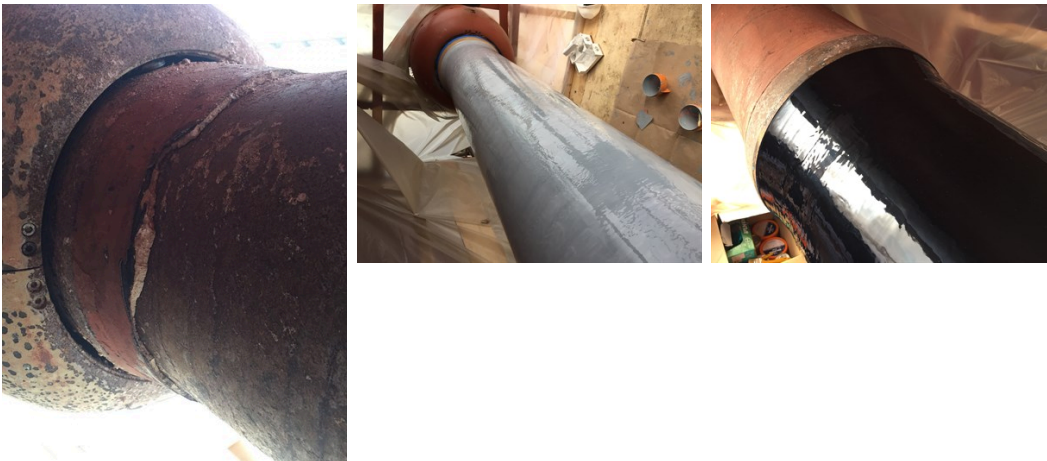
*Previous coating had failed by delamination, causing the shaft body to corrode.*

- \* The failed coating and corroded shaft. ,
- \* Shaft protected with Belzona 1341. ,
- \* The finished job with the Belzona elastomer coating. ,

Application was carried out in accordance with a modified version of Belzona Know-How System Leaflet SOS-6.

As previous coating system had failed, the Customer was looking for a long-term protective solution. Belzona 1341 and Belzona 2141 system protected this vessel's propeller shaft long into the future.
