Cooling Water Outlet Protected with Belzona 1321

ID: 7792

Industry: Power
Application: VPF-Valves, Pipes and Fittings
Substrate: Mild steel
Products: * Belzona 1321 (Ceramic S-Metal) ,

Customer Location: Ireland
Application Date: September 2018

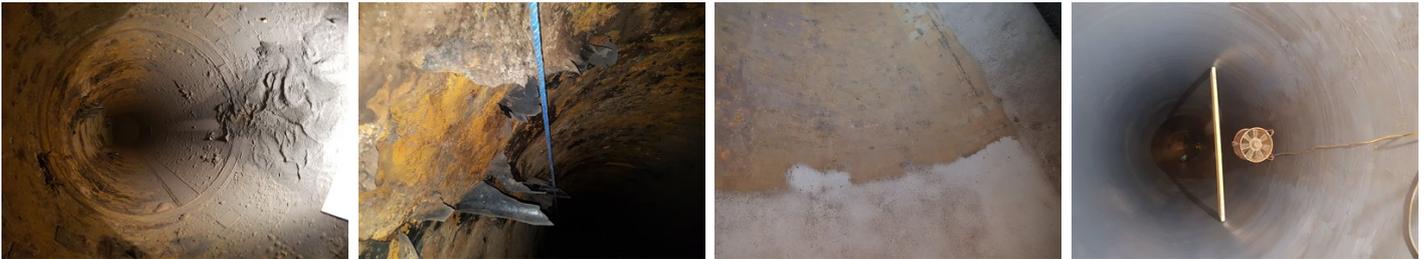
Photograph Descriptions

The existing rubber lining had reached its end of life. The existing rubber was no longer providing the steel pipes with protection from erosion/corrosion. The rubber needed to be removed to allow for application of Belzona 1321.

- * Rubber lining in outlet pipe ,
- * Condition of rubber lining ,
- * Blasting in progress ,
- * Finished Belzona 1321 ,

The rubber was stripped. The steel was grit blasted and then washed to removed all salts. The steel was blasted back to ISO 8501 SA 2 1/2 and Belzona 1321 was applied in two coats.
