Cooling Water Spools after 5 years in service with Belzona

Industry: *Fluid Flow*Customer Location: *Ireland*

Application Date: *2013*Substrate: *Steel*Products: ** Belzona 1321 (Ceramic S-Metal) ,*

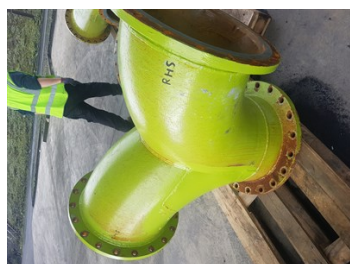
- * 1. Y- piece ,
- * 2. Condition of Belzona 1321 ,
- * 3. Elbow ,
- * 4. Condition of Belzona 1321 ,

The internal walls of several spools from the auxiliary cooling water system were coated with Belzona 1321 back in 2013. In 2018 the spools were removed for inspection still showing to be in excellent condition.

This application was carried out in accordance with system leaflet VPF-02. Originally the internals of the spools were grit blasted to SA2.5 and then coated with Belzona 1321. During the inspection in 2018 some minor repairs were carried out on the flange area and internal walls of the spools. Any area's that needed minor repairs were washed with Salt-Away and then grit blasted before reapplying some Belzona 1321.
