Cooling Water Spools after 5 years in service with Belzona

ID: 7793

Industry: *Fluid Flow*

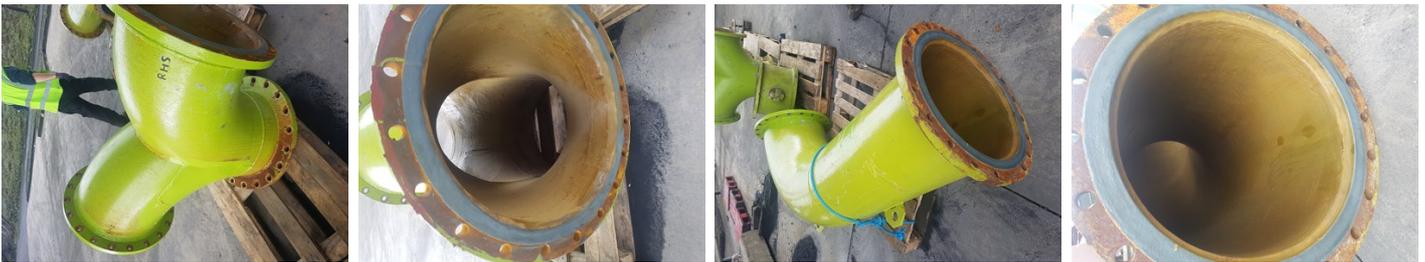
Photograph Descriptions

Corrosion and erosion from the sea water going through the spools.

- * 1. Y- piece ,
- * 2. Condition of Belzona 1321 ,
- * 3. Elbow ,
- * 4. Condition of Belzona 1321 ,

The internal walls of several spools from the auxiliary cooling water system were coated with Belzona 1321 back in 2013. In 2018 the spools were removed for inspection still showing to be in excellent condition.

This application was carried out in accordance with system leaflet VPF-02. Originally the internals of the spools were grit blasted to SA2.5 and then coated with Belzona 1321. During the inspection in 2018 some minor repairs were carried out on the flange area and internal walls of the spools. Any area's that needed minor repairs were washed with Salt-Away and then grit blasted before reapplying some Belzona 1321.

The spools were originally rubber lined. The rubber lining was removed in 2013 and Belzona 1321 was applied.
