Agitator Protected From Acid Attack by Belzona

Application: FBC-Fans, Blowers and Compressors

Agitator blades exposed to chemical attack and erosion in copper plant.

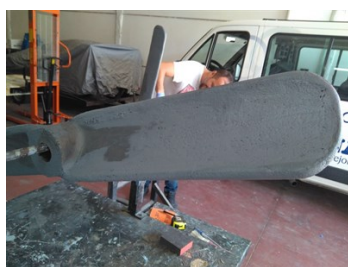
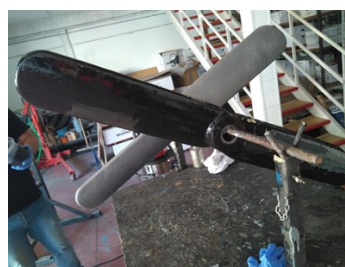
Concentrated sulfuric acid at elevated temperatures was causing deterioration of the agitator blades, which were being replaced every 4 months as a result.

- * 1. Damage to Blades ,
- * 2. Rebuilt with Belzona 1511 ,
- * 3. First coat applied ,
- * 4. Completed application ,

Application was carried out in accordance using a modified version of System Leaflet FBC-2.

fluid. They had tried a rubber coating to protect the blades, however the poor chemical resistance to the acid and temperature caused the rubber lining to fail quickly. It was concluded that erosion may not be the main cause of the damage, hence the customer wanted to trial a chemical resistant lining. As the conditions are 40% Sulfuric Acid at 80degC, Belzona 4341 is the best choice. An aggregate was incorporated into the coating to add some erosion resistance.
