# Belzona Protects a Roof Above Transformers

**Industry:** Buildings & Structures  
**Application:** RPA-Roof Problem Areas  
**Substrate:** Steel and bitumen coating  
**Products:** \* Belzona 3921 (GSC Surface Conditioner) ,  
\* Belzona 3111 (Flexible Membrane) ,

**Customer Location:** Belgium  
**Application Date:** 2018

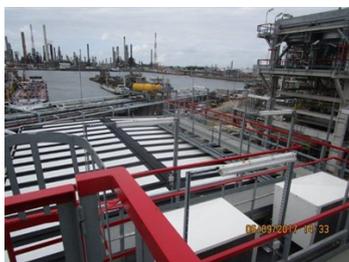
The roof had been protected with a bitumen coating, however, this was found to be unsatisfactory by the customer. As well as this, thanks to the building not being built to specifications, there were an estimated 160 perforations across the whole of the roof. This needed to be repaired and protected given the fact that the roof protects transformers and leaks could be very dangerous.

- \* Overview of the roof before the application ,
- \* A close-up view of the roof before application ,
- \* Final application ,

The application began with the steel roof being cleaned with water and powder cleaner to remove all surface contaminants. According to a modified version of Belzona Know-How System Leaflet RPA-1, the surface was then manually roughened. A coat of Belzona 3921 Conditioner was then applied followed by a two-coat system of Belzona 3111 with a reinforcement sheet used in the first coat.
