Belzona Protects a Roof Above Transformers

ID: 7798

Industry: Buildings & Structures
Application: RPA-Roof Problem Areas
Substrate: Steel and bitumen coating
Products: * Belzona 3921 (GSC Surface Conditioner) ,
* Belzona 3111 (Flexible Membrane) ,

Customer Location: Belgium
Application Date: 2018

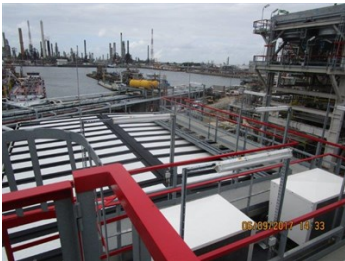
The roof had been protected with a bitumen coating, however, this was found to be unsatisfactory by the customer. As well as this, thanks to the building not being built to specifications, there were an estimated 160 perforations across the whole of the roof. This needed to be repaired and protected given the fact that the roof protects transformers and leaks could be very dangerous.

- * Overview of the roof before the application ,
- * A close-up view of the roof before application ,
- * Final application ,

The application began with the steel roof being cleaned with water and powder cleaner to remove all surface contaminants. According to a modified version of Belzona Know-How System Leaflet RPA-1, the surface was then manually roughened. A coat of Belzona 3921 Conditioner was then applied followed by a two-coat system of Belzona 3111 with a reinforcement sheet used in the first coat.
