Belzona Protects Washing Powder Hoppers

ID: 7800

Application: TCC-Tanks and Chemical Containment Areas

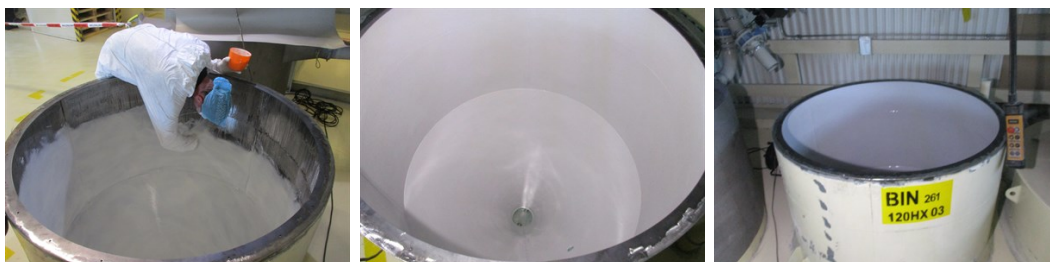
The citric acid content of the washing powder was causing erosion-corrosion to the supply hoppers

- * Application in progress, showing the unprotected substrate ,
- * Closeup of the finished coating ,
- * The equipment at hand ,

The application was carried out in accordance with Belzona System Leaflet TCC-3. Belzona 1331 was applied by brush.

A Belzona coating was chosen as the Customer sought after a long-term corrosion protection against citric acid, whilst also having the durability to withstand dry abrasion from powder.
