Belzona Repairs and Protects Chimney Masonry

Industry: Power
Application: WPA-Wall Problem Areas
Substrate: Brickwork
Products: * Belzona 4111 (Magma-Quartz) ,
* Belzona 4141 (Magma-Built) ,
* Belzona 4151 (Magma-Quartz Resin) ,
* Belzona 4341 (Magma CR4) ,
* Belzona 4911 (Magma TX Conditioner) ,

Customer Location: Czech Republic
Application Date: May 2015

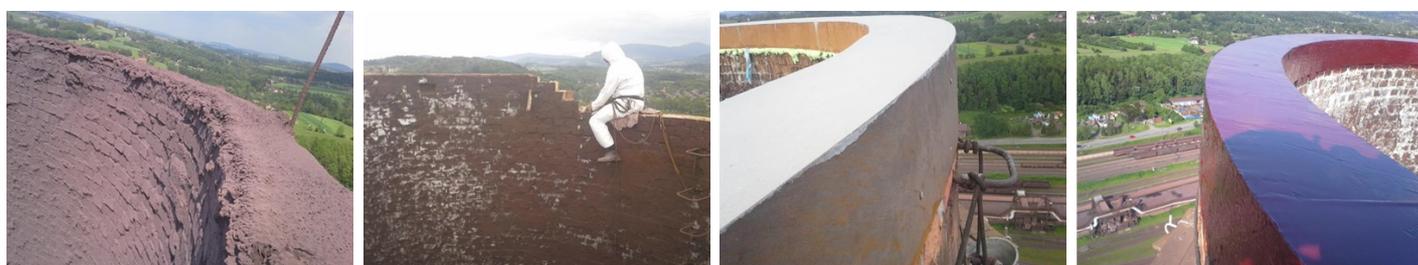
Photograph Descriptions

The top of the stack had deteriorated due to flue gas and water ingress, causing the mortar to break down and bricks to become loose.

- * The deteriorated stack. ,
- * Work underway. ,
- * The sheet metal formers with finished Belzona 4111. ,
- * The finished job with Belzona 4341 coating. ,

The application was carried out in accordance with a modified version of Belzona Know-How System Leaflet WPA-4. The top profile was reformed with new brickwork and Belzona 4111 using preformed sheet metal formers around the outer and inner circumference as guides. The deteriorated mortar was then repaired using Belzona 4141 due to its lightweight properties allowing repair on vertical surfaces. The whole area was then coated with Belzona 4341 to give long term protection against flue gases.
