Underwater Exhaust Repaired on a 230' Super Yacht

ID: 7808

Elbow of a 7'L x 19"D underwater starboard exhaust for the main engines.

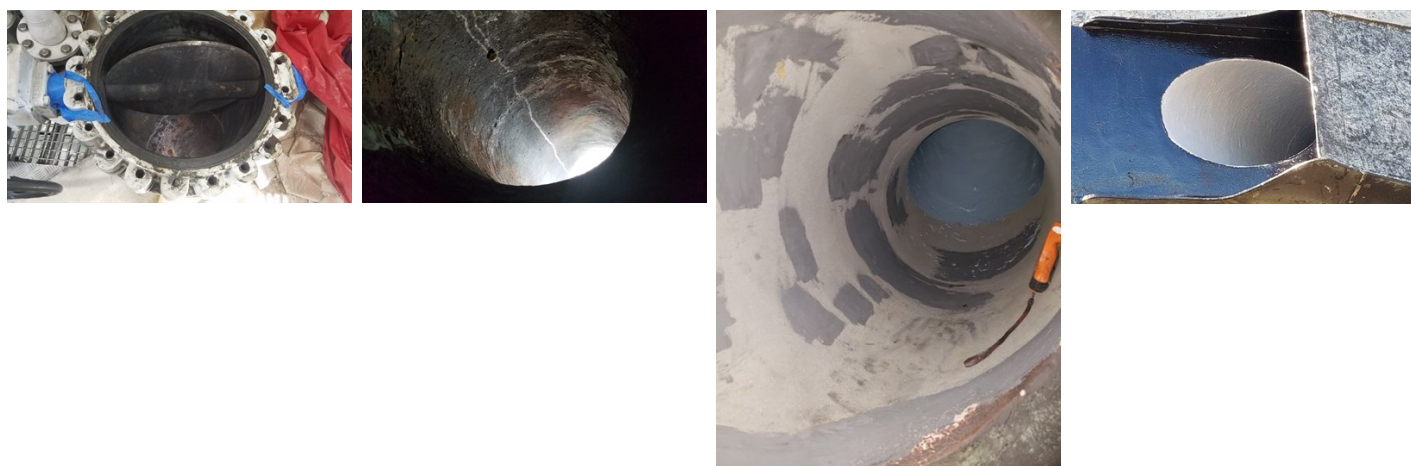
Photograph Descriptions

Elbow metal pitting and thinning. Heat from the exhausts gets to 70C.

- * From the engine room view of the top of the underwater exhaust ,
- * Damage of the underwater exhaust ,
- * Application of Belzona 1511 to various damaged areas inside the exhaust ,
- * Final coat of Belzona 1391T grey ,

The application was carried out in accordance with modified versions of Belzona Know-How System Leaflets SOS-1 and SOS-2. The surface was prepared by abrasive blast cleaning. A containment was created on both ends of the exhaust to protect the engine room and to protect the exposed blasted steel from the outside elements. The surface was blast cleaned to a near white metal finish to achieve a 3 mill angular profile to apply the Belzona protective system. Belzona 1511 was used to rebuild damaged surfaces, and Belzona 1391T was applied to add protection.
