BELZONA REBUILDS AND PROTECTS HEX END BELL AND CAP AT A BEVERAGE FACILITY

ID: 7809

Application: *HEX-Heat Exchangers*

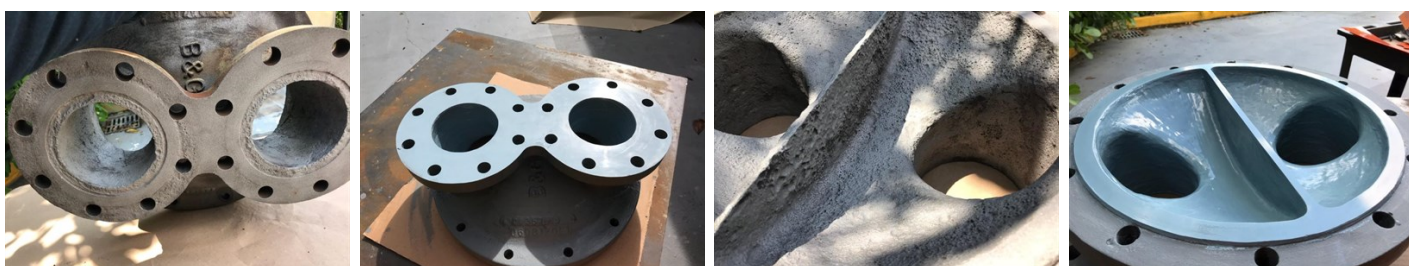
Photograph Descriptions

Erosion-corrosion wear caused by having no protective coating before the heat exchanger started its service life.

- * End Cap after abrasive blasting ,
- * End Cap after application of Belzona 1511 and 1391T ,
- * End Bell after abrasive blasting ,
- * End Bell after application of Belzona 1511 and 1391T ,

The application was carried out in accordance with modified versions Know-How System Leaflets: HEX-2 and HEX-3. Both the end bell and the cap was abrasive blasted to a near white metal finish with an angular profile of 3 mills. Belzona 1511 was used to rebuild the steel substrate for high conditions Belzona 1391T to protect the steel substrate for high heat conditions.
