HITCH BEARING RE-FIT WITH BELZONA

ID: 781

Top center bearing on Volvo articulated truck.

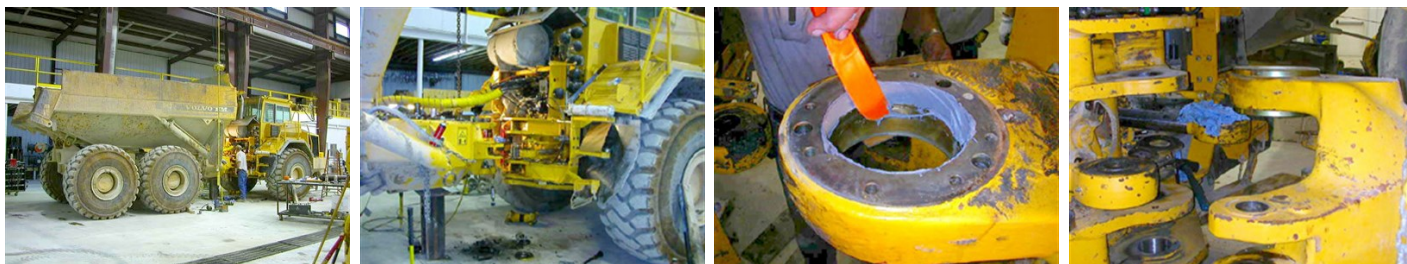
Photograph Descriptions

The truck was needed back in service within 12 hours and the broken bearing had damaged the hitch bore.

* View of 40T Articulated truck , * View of the hitch , * Top bearing coated with Belzona® 1111 , * Both bearings fitted, ready to be coupled to trailer ,

Application was carried out in accordance with Belzona Know-How System Leaflet MPT-7. No Release agent was used as this bearing will be run to destruction so the new outer races were bonded in place.
