BELZONA COLD PLATE BONDING SAVES A STORAGE TANK'S ROOF

ID: 7810

Roof top of an oil storage tank in a port authority facility.

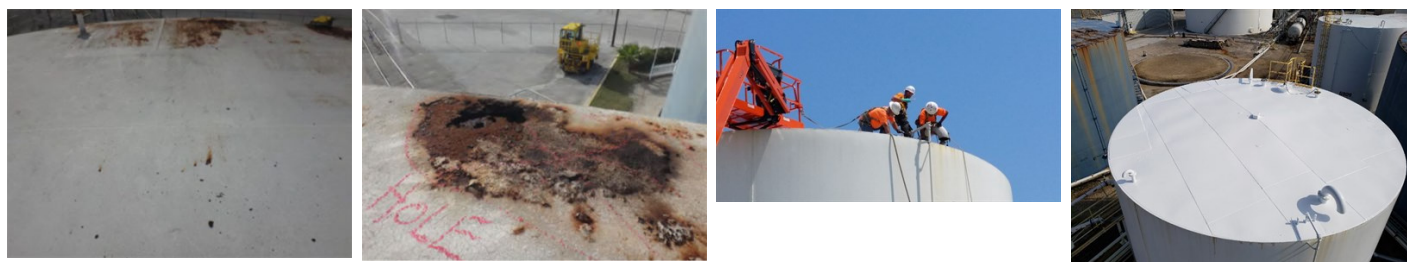
Photograph Descriptions

Roof top near edges exhibited thinned metal and through holes.

- * Tank roof top exhibiting damaged areas ,
- * Thinned and holed areas near the edge of the tank roof ,
- * Job discussion with the Contractors ,
- * Completed plate bonding ,

Plates could not be welded to the remaining substrate. Cold plate bonding technique was chosen to cover roof top holed areas. The Customer's contractor removed large thinned sections of the roof top and prepped the remaining substrate by a hand-held grinder. New steel plates had been pre-cut and abrasive blasted to a near white metal finish with a 3 mill angular profile. Belzona 1161 was mixed - the roof top surface had been wetted out with a small 2" cut chip brush. At the same time the remaining mixed material was applied to the bottom of the new steel plates creating a build-up in the center of the plates to allow Belzona 1161 to spread out evenly filling all the voids.

Provided the scale of the damage and inability to use welding, Belzona cold plate bonding was the only solution possible. Belzona 1161 was selected due to its surface-tolerant abilities as using abrasive blasting to the tank's roof was not an option. The application was completed with zero hot work thus making it a safe application for the Contractors and facility.
