# Blast Furnace Gas Leak Pipe Repair

ID: 7814

*Steel plant blast furnace gas inlet had developed a leak and was losing pressure. The repair needed to be done whilst equipment was online.*

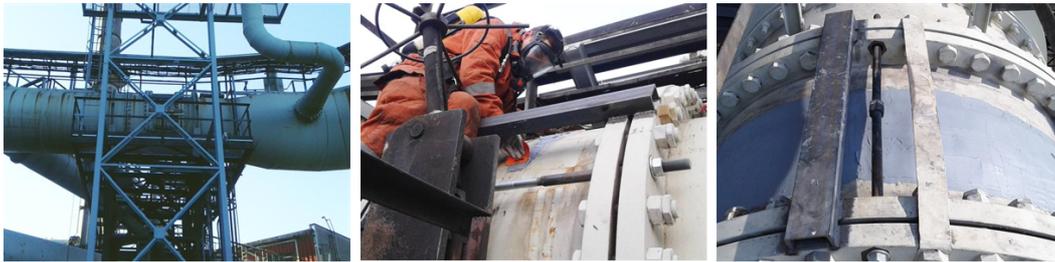
- \* The blast furnace gas inlet. ,
- \* The repair is underway. ,
- \* The finished repair. ,

The gas leak was causing a risk of explosion, so Belzona 1211 was used to initially seal the crack and stem the flow of gas. Once the leak was stopped, the necessary surface preparation was carried out with a grinder so that a stronger reinforcement of Belzona 1111 and Belzona 9341 reinforcement mesh could be applied to the pipe to provide a long-term reinforcement to the damaged area.
