Blast Furnace Gas Leak Pipe Repair

ID: 7814

Industry: *Steel & Metal Processing*

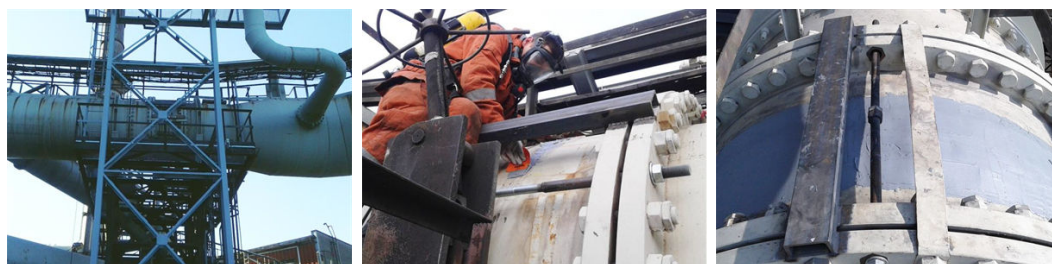
Steel plant blast furnace gas inlet had developed a leak and was losing pressure. The repair needed to be done whilst equipment was online.

- * The blast furnace gas inlet. ,
- * The repair is underway. ,
- * The finished repair. ,

The gas leak was causing a risk of explosion, so Belzona 1211 was used to initially seal the crack and stem the flow of gas. Once the leak was stopped, the necessary surface preparation was carried out with a grinder so that a stronger reinforcement of Belzona 1111 and Belzona 9341 reinforcement mesh could be applied to the pipe to provide a long-term reinforcement to the damaged area.
