# Belzona Repairs Cooling Water Pipe at a Steel Plant

ID: 7818

Steel plant cooling water pipe.

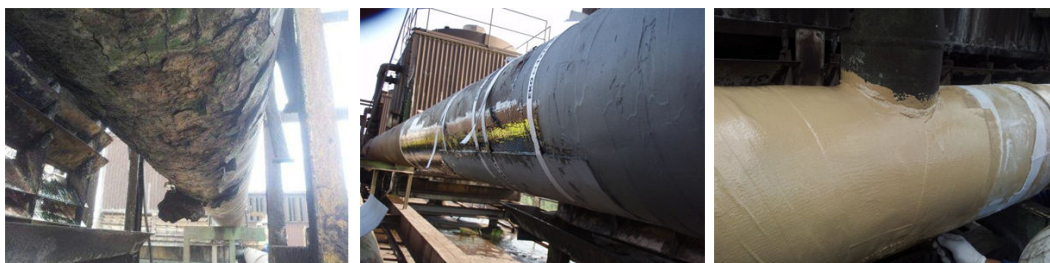
*Corrosion had caused heavy damage on cooling water pipe, therefore weakening the jacket. This may have eventually led to a through-wall defect which would cause a costly downtime period.*

- \* The original corroded pipework ,
- \* Belzona 1111 applied to restore the thinned walls. ,
- \* Belzona 5811 reinforcement ,
- \* The finished job ,

After removing the impurities, the pipeline was treated with the Belzona 5831 coating system. Subsequently, the areas were pressed with Belzona 1111 and reinforced with reinforcing sheets. At the end, the entire pipe casing was treated with a two-component coating system for a long-term protection of Belzona 5811 in combination with Belzona 9341 reinforcement tape.
