Internal Repair and Protection of a Split Case Pump with Belzona 1341

ID: 7819

Customer Location: France
Application Date: June 2014

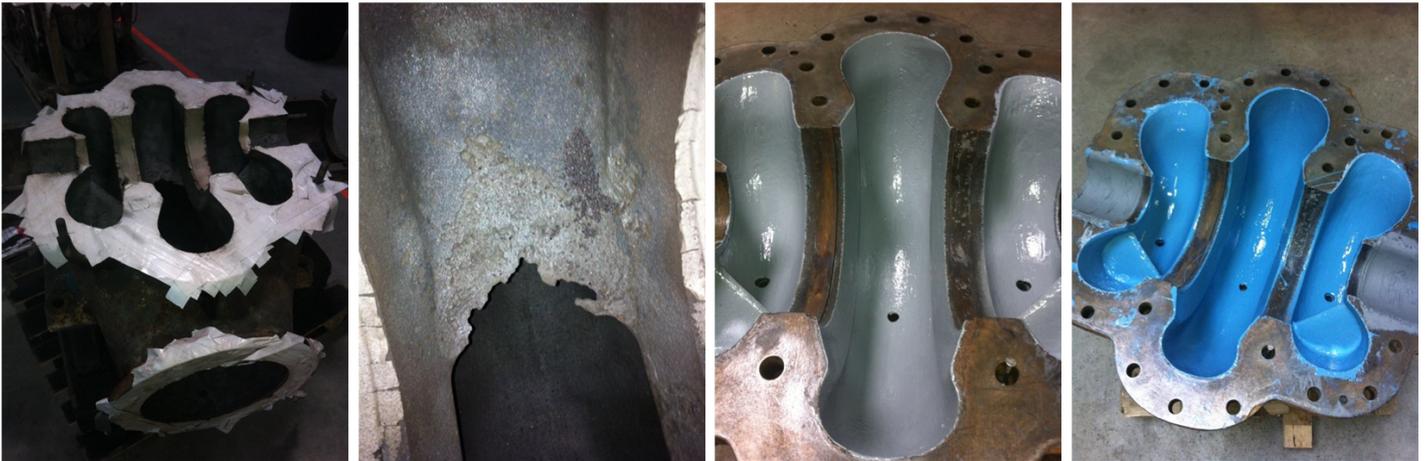
The internal surface of this splitting-case pump was badly damaged by corrosion and needed to be rebuilt and protected.

- * Before the application ,
- * Showing the damage on the internal part of the pump ,
- * First coat of Belzona 1341 in grey ,
- * Second coat of Belzona 1341 in blue ,

The substrate was first grit blasted and cleaned with acetone. Then the displacement nose was rebuilt using Belzona 1111. Finally, the whole internal surface was protected with 2 coats of Belzona 1341. The application was carried out in accordance with Belzona system leaflet CEP-3.

The advantage of the system is that a possible wear of the coating would be easily identified thanks to the 2 different colours used

(grey and blue). Besides, the smoothness of the coating can also increase the pump efficiency.
