# Roller Shaft Re-built with Belzona

ID: 7826

Industry: *Steel & Metal Processing*  
Application: *FBC-Fans, Blowers and Compressors*

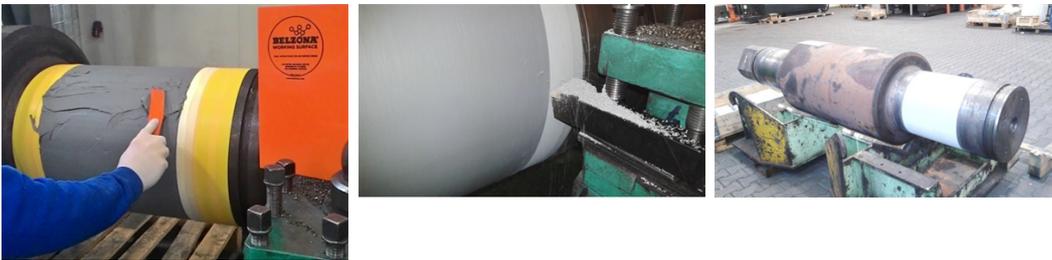
*The 400mm shaft for the roller in this steel mill had become damaged and developed 6mm of headspace inside the bearing, and therefore needed reprofiling.*

- \* Belzona 1111 used to build the profile up. ,
- \* The Belzona being machined back on the lathe. ,
- \* The completed repair. ,

The prepared surface was cleaned using Belzona 9111. The profile was rebuilt with Belzona 1111, then machined back to the correct diameter using a lathe.
