Roller Shaft Re-built with Belzona

ID: 7826

Industry: *Steel & Metal Processing*
Application: *FBC-Fans, Blowers and Compressors*

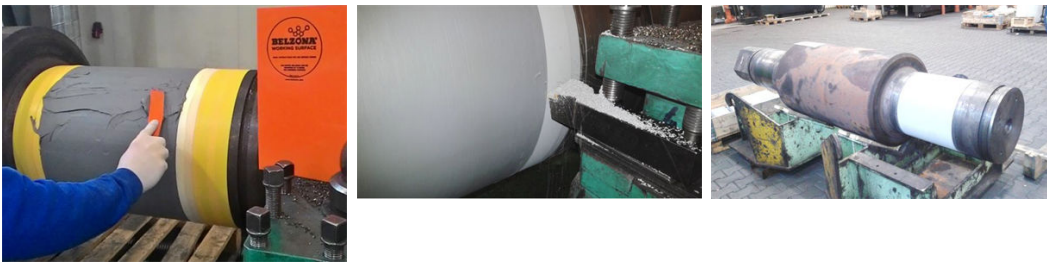
Photograph Descriptions

The 400mm shaft for the roller in this steel mill had become damaged and developed 6mm of headspace inside the bearing, and therefore needed reprofiling.

- * Belzona 1111 used to build the profile up. ,
- * The Belzona being machined back on the lathe. ,
- * The completed repair. ,

The prepared surface was cleaned using Belzona 9111. The profile was rebuilt with Belzona 1111, then machined back to the correct diameter using a lathe.
