Belzona Shaft Repair By Forming Technique at a Paper Mill

ID: 7835

Shaft on a vacuum pump at a paper mill.

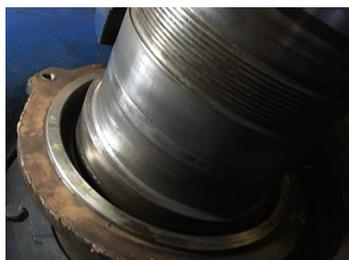
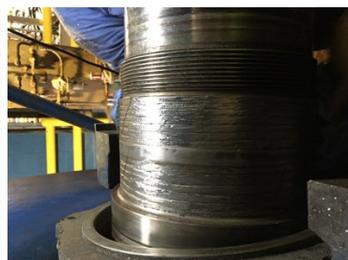
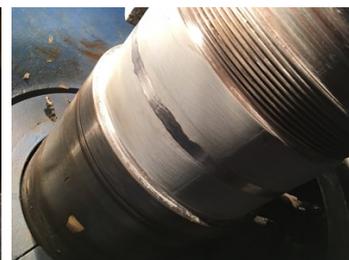
Bearings spun on shaft taking with it an estimated .080 or 80 thousandths from the shaft.

* Former that was made and used.
 Damaged shaft.
 Shaft prepared/surface roughened up.
 Finished application. ,

This application was carried out in accordance with a modified version of Belzona Know-How System Leaflet MPT-2 (Shaft Repair by Forming Technique). The area was prepared by using a small disk grinder which was used to cut grooves into the shaft then was roughened by using a bur bit. The shaft was thoroughly cleaned using Belzona 9111. Belzona 9411 was placed on the former and on the shaft where product was not wanted. Belzona 1111 was placed on the shaft and on the former and squeezed together. After a few hours the former was removed and the shaft was dressed up making sure to remove any unwanted Belzona 1111.
