BELZONA PROTECTS PULP BEATER

Industry: *Pulp & Paper*
Application: *CEP-Centrifugal Pumps*
Substrate: *Cast iron*
Products: ** Belzona® 1311 (Ceramic R Metal) ,*
** Belzona® 1321 (Ceramic S Metal) ,*

Customer Location: *Paper Mill, Maglio, Italy*
Application Date: *June, 2006*

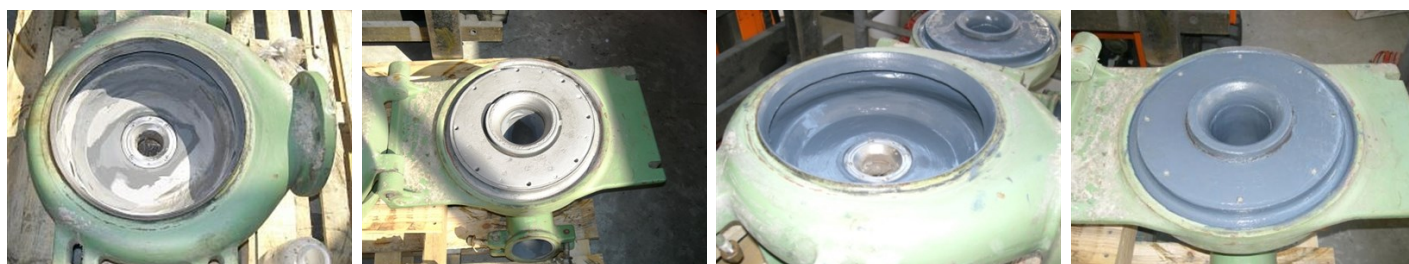
Photograph Descriptions

Erosion corrosion wear on body and cover caused by paper pulp.

- * Inside the beater after blasting. Remaining Belzona still evident. ,
- * Cover after grit blasting. ,
- * Body and cover coated with Belzona. ,
- * Beater cover after application. ,

The application was carried out in accordance with Belzona Know-How System Leaflets CEP-3 and CEP-5.

The equipment had previously been coated in 2000 and this application was to renew the eroded coating. Replacement of Belzona cost a fraction of replacement unit.
