# BELZONA SPHERE LINING ROLLED OUT

**Industry:** Oil & Gas  
**Application:** VPF-Valves, Pipes and Fittings  
**Substrate:** Carbon steel  
**Products:** \* Belzona 1111 (Super Metal) ,  
\* Belzona 4311 (Magma CR1) ,

**Customer Location:** Oil & Gas Production, UK  
**Application Date:** 2010 - 2018

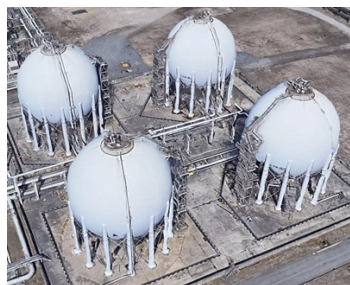
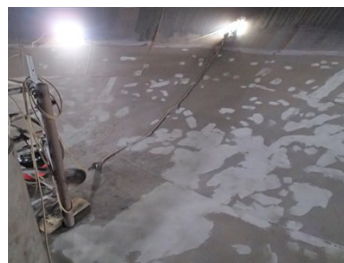
- \* Storage spheres from the air. ,
- \* Plan of coating height. ,
- \* Lowest section filled with Belzona 1111. ,
- \* Lowest section completed with Belzona 4311. ,

Prequalification trials proved the Belzona 4311 could be sprayed using plural feed equipment and the first sphere was coated in 2010, in accordance with a modified version of Belzona Know-How System Leaflet TCC-5. Small bore nozzle inserts were installed using a modified version of Belzona Know-How System Leaflet TCC-16a.
