BELZONA SPHERE LINING ROLLED OUT

Industry: Oil & Gas
Application: VPF-Valves, Pipes and Fittings
Substrate: Carbon steel
Products: * Belzona 1111 (Super Metal) ,
* Belzona 4311 (Magma CR1) ,

Customer Location: Oil & Gas Production, UK
Application Date: 2010 - 2018

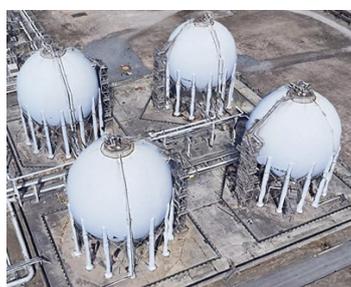
- * Storage spheres from the air. ,
- * Plan of coating height. ,
- * Lowest section filled with Belzona 1111. ,
- * Lowest section completed with Belzona 4311. ,
