# Belzona Elastomer Solution Filters Out the Competition

ID: 7853

Industry: Power  
Application: TCC-Tanks and Chemical Containment Areas  
Substrate: Steel  
Products: \* Belzona 1331 ,

Customer Location: Qatar  
Application Date: January 2015 - Ongoing

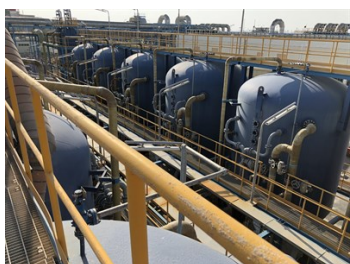
*The rubber lining for a 15-year-old limestone filter was suffering from severe disbondment and failure. In fact, it was unable to sustain the operation of filtering water on a daily basis due to aggressive erosion.*

- \* Limestone filters at the Power Plant. ,
- \* Alternative rubber lining disbonded during a trial phase. ,
- \* Alternative protective coating blistered during a trial phase. ,
- \* Belzona 1331 - No traces of failure after 8-month trial period. ,
