Belzona Elastomer Solution Filters Out the Competition

ID: 7853

Industry: Power
Application: TCC-Tanks and Chemical Containment Areas
Substrate: Steel
Products: * Belzona 1331 ,

Customer Location: Qatar
Application Date: January 2015 - Ongoing

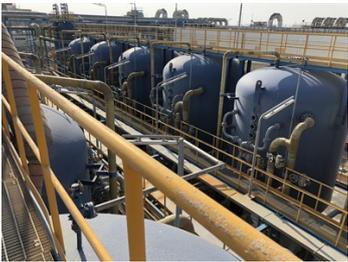
- * Limestone filters at the Power Plant. ,
- * Alternative rubber lining disbonded during a trial phase. ,
- * Alternative protective coating blistered during a trial phase. ,
- * Belzona 1331 - No traces of failure after 8-month trial period. ,

15-year-old limestone filter at a power plant.
