Belzona Repairs 42 Bar Active Gas Leak

ID: 7854

Industry: General Industry
Application: VPF-Valves, Pipes and Fittings
Substrate: Steel pipe
Products: * Belzona 9611 ,
* Belzona 1111 (Super Metal) ,

Customer Location: Egypt
Application Date: 2018

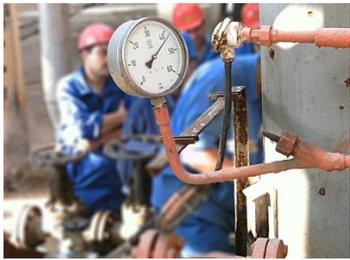
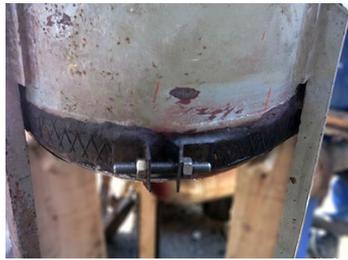
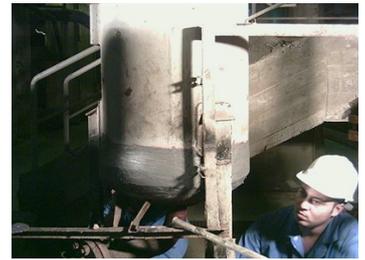
Photograph Descriptions

Natural gas active leak developed and their safety department was about to shut down the plant to repair this dangerous leakage. This gas leak was also causing a loss in pressure to the rest of the plant, reducing efficiency and output.

- * Pressure gauge on pipe showing 42 bar ,
- * Belzona 9611 clamped down on the repair ,
- * The application of Belzona 1111 underway ,
- * Work Complete ,

Belzona 9611 was applied into the immediate leak area with a clamp to hold it in place during curing. The application was carried out by 7 technicians at the same time due to the limited curing time. The pipe was then reinforced with Belzona 1111 to complete the repair. The application was carried out in accordance with a Belzona Know-How System Leaflet VPF-11.

The only alternative to the Belzona solution would have been to shut down the plant, as this vessel was reducing gas pressure for the whole plant. A shutdown would have cost millions in lost production, so it was critical to keep the plant running. Conventional welding repairs were not an option due to the gas leak. Based on an existing relationship with the Customer, they wanted to try a cold-curing repair which worked exceptionally well. The application duration was one working day and they inspected the repair by a gas detector device.
