Belzona Repairs 42 Bar Active Gas Leak

ID: 7854

Industry: General Industry
Application: VPF-Valves, Pipes and Fittings
Substrate: Steel pipe
Products: * Belzona 9611 ,
* Belzona 1111 (Super Metal) ,

Customer Location: Egypt
Application Date: 2018

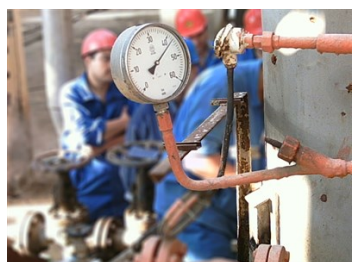
- * Pressure gauge on pipe showing 42 bar ,
- * Belzona 9611 clamped down on the repair ,
- * The application of Belzona 1111 underway ,
- * Work Complete ,

Belzona 9611 was applied into the immediate leak area with a clamp to hold it in place during curing. The application was carried out by 7 technicians at the same time due to the limited curing time. The pipe was then reinforced with Belzona 1111 to complete the repair. The application was carried out in accordance with a Belzona Know-How System Leaflet VPF-11.
