Belzona Repairs 42 Bar Active Gas Leak

ID: 7854

Customer Location: Egypt
Application Date: 2018

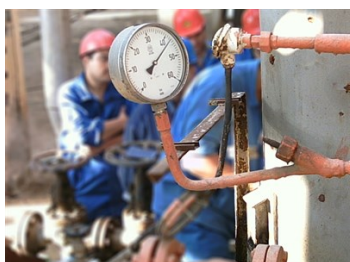
- * Pressure gauge on pipe showing 42 bar ,
- * Belzona 9611 clamped down on the repair ,
- * The application of Belzona 1111 underway ,
- * Work Complete ,

Belzona 9611 was applied into the immediate leak area with a clamp to hold it in place during curing. The application was carried out by 7 technicians at the same time due to the limited curing time. The pipe was then reinforced with Belzona 1111 to complete the repair. The application was carried out in accordance with a Belzona Know-How System Leaflet VPF-11.
