Belzona repairs the suction part of a hydro turbine

Suction part of a hydro turbine from a hydroelectric plant

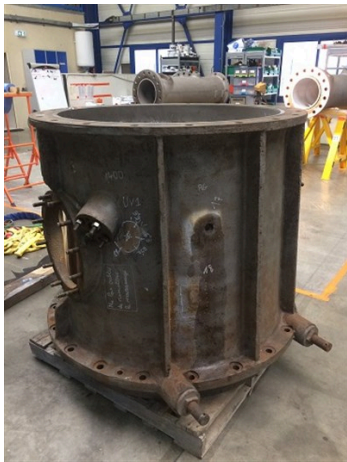
The internal surface of this hydro turbine presented an important loss of metal which ultimately led to a hole.

- * 1- Before application ,
- * 2- After grit blasting ,
- * 3- Application of Belzona 1311 ,
- * 4- After application ,
