Belzona repairs the suction part of a hydro turbine

ID: 7858

Suction part of a hydro turbine from a hydroelectric plant

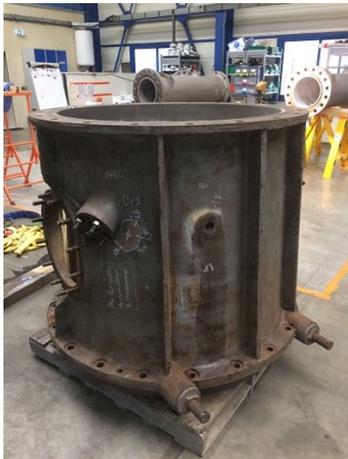
The internal surface of this hydro turbine presented an important loss of metal which ultimately led to a hole.

- * 1- Before application ,
- * 2- After grit blasting ,
- * 3- Application of Belzona 1311 ,
- * 4- After application ,

After preparing the surface by grit blasting, the hydraulic profile of the equipment was rebuilt from the inside using Belzona 1311. Two coats of Belzona 1331 were then applied to provide a long-term protection against erosion and corrosion. On the outside of the equipment, patches of SuperWrap were used to recover the mechanical strength of the equipment.
