Belzona repairs the suction part of a hydro turbine

Suction part of a hydro turbine from a hydroelectric plant

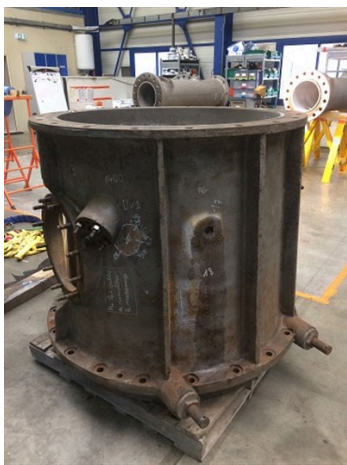
The internal surface of this hydro turbine presented an important loss of metal which ultimately led to a hole.

- * 1- Before application ,
- * 2- After grit blasting ,
- * 3- Application of Belzona 1311 ,
- * 4- After application ,

After preparing the surface by grit blasting, the hydraulic profile of the equipment was rebuilt from the inside using Belzona 1311. Two coats of Belzona 1331 were then applied to provide a long-term protection against erosion and corrosion. On the outside of the equipment, patches of SuperWrap were used to recover the mechanical strength of the equipment.
