Belzona repairs and protects a Sand filter at a Nuclear Power Plant

ID: 7859

Sand filter in a Nuclear power plant

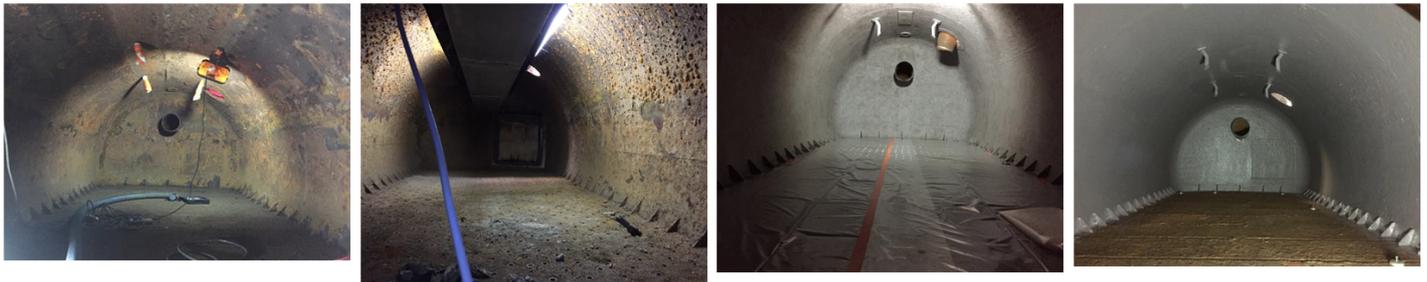
Photograph Descriptions

Internal corrosion

- * 1- Before application ,
- * 2- Surface aspect before surface preparation ,
- * 3- After surface preparation ,
- * 4- After application ,

The application was carried out in accordance with Belzona Know How System Leaflet TCC-5. After grit blasting the substrate, it was degreased and the pitting was repaired with Belzona 1111. The surface was then protected with Belzona 1321 to prevent any future corrosion.
